STRUCTURE CONDITION REPORT

BARGE CANAL FAIRPORT-LOCKPORT

MATERIALS BUREAU

STRUCTURE CONDITION REPORT
BARGE CANAL - WESTERN SECTION
FAIRPORT TO LOCKPORT

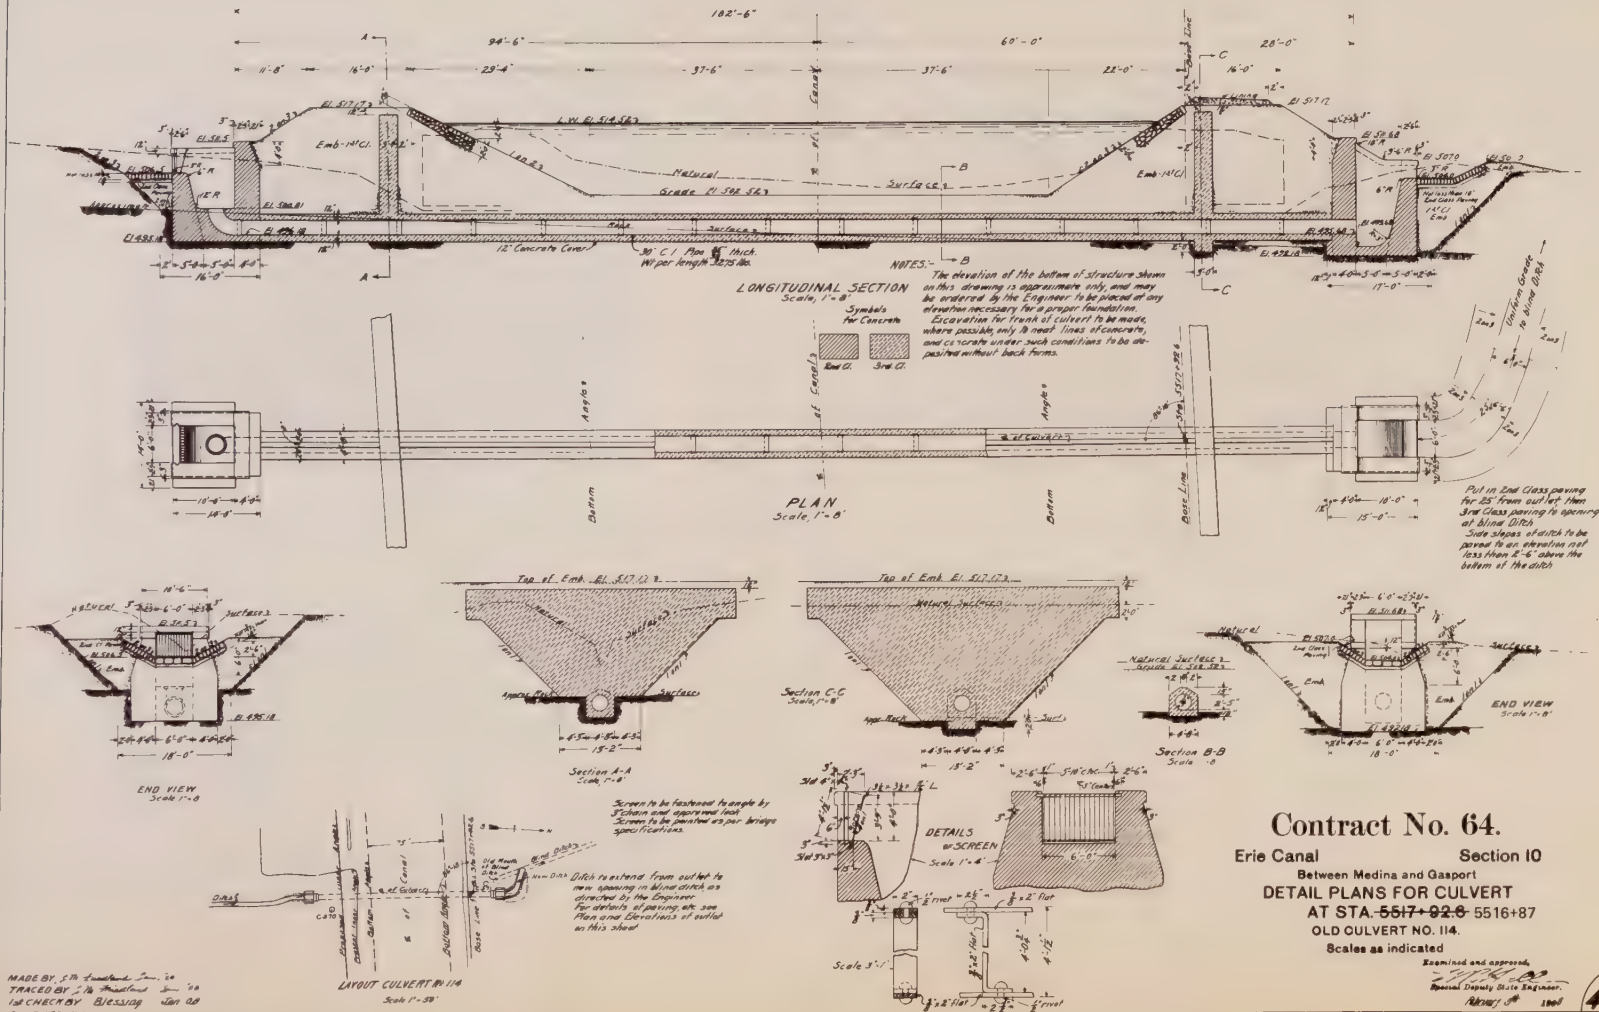
The concrete culvert was in good condition. Slow seepage through most of the joints.

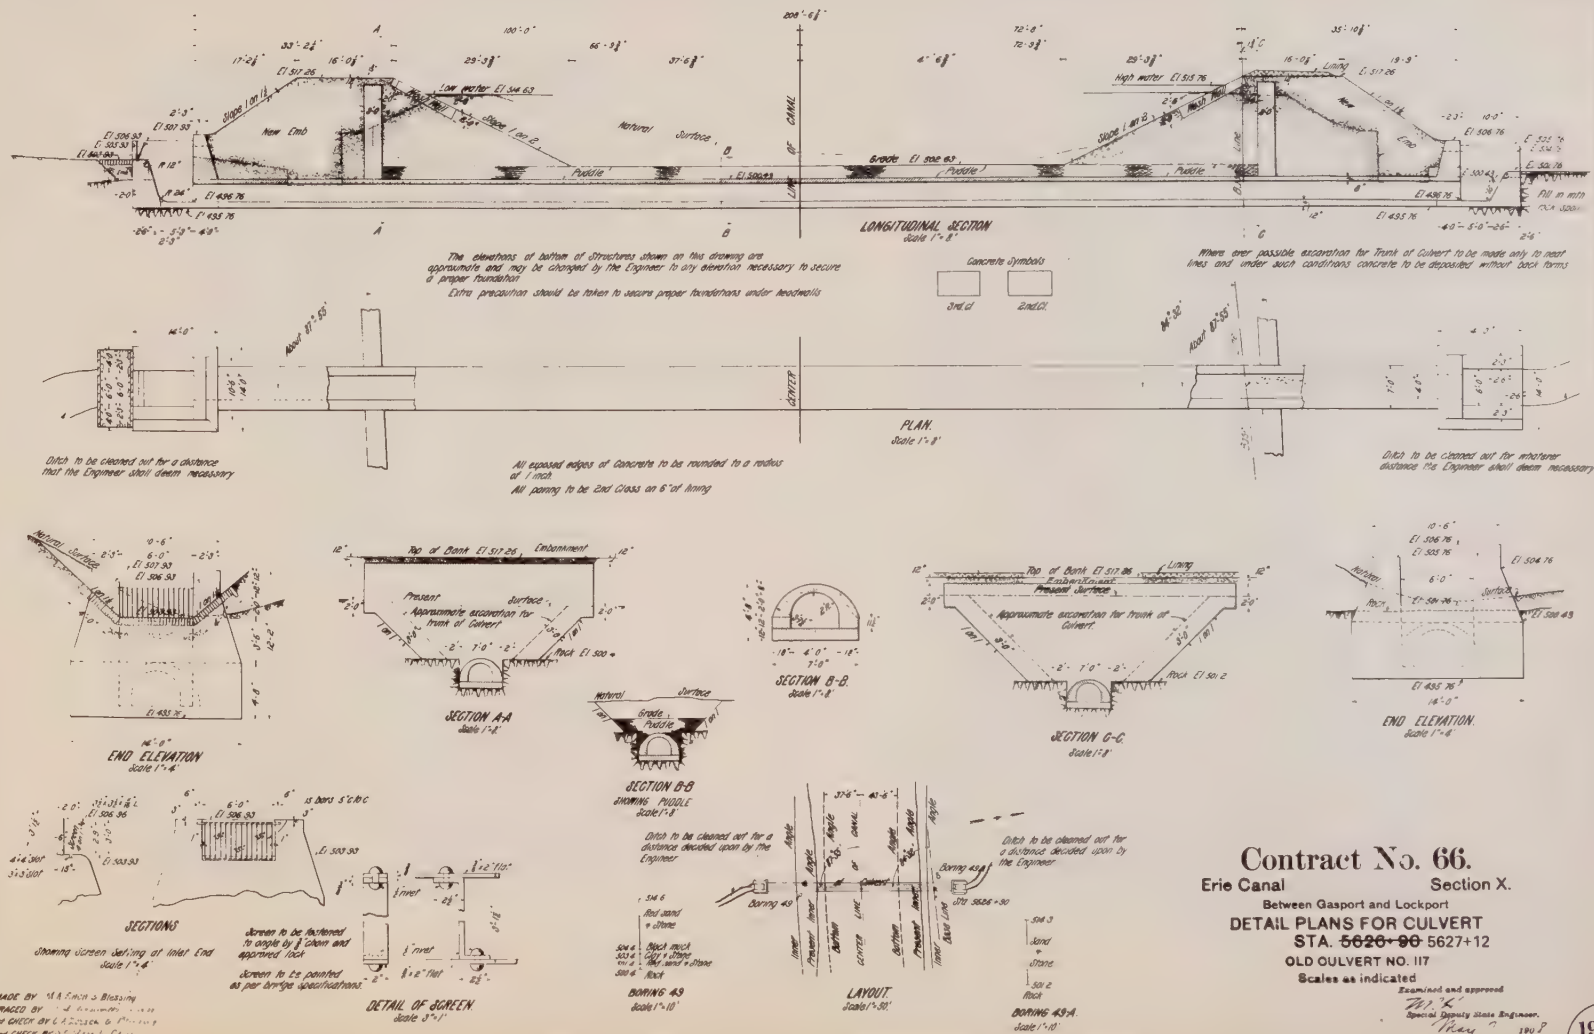
Exit
Headwall and wingwalls in good condition.
A few cracks at near end of right wingwall.

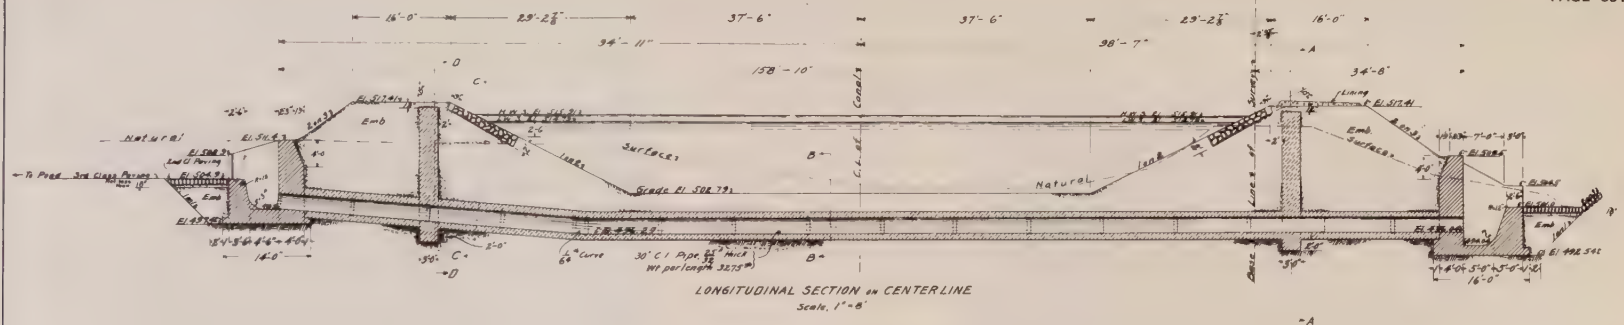
Exit
Looking down into pumped out culvert well.
